How Hurricanes Have Impacted Sediment Transport on the Renourished Beaches of Gasparilla Island State Park in Boca Grande, FL.

College of Coastal Georgia, Department of Natural Sciences, Environmental Sciences Program

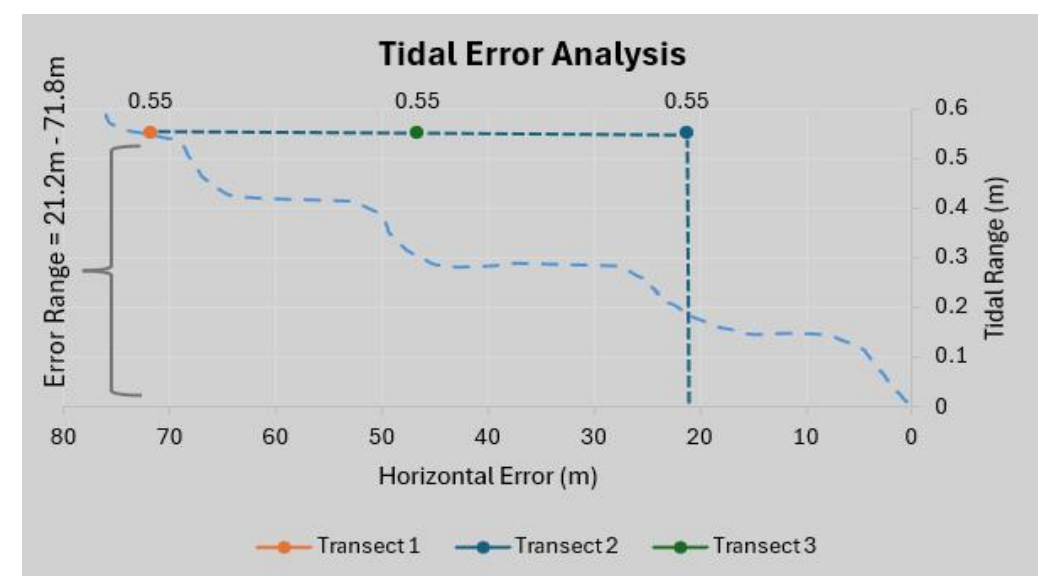
Figure 6. Tidal range error analysis using 3 transects. This was used to establish the variability between 21.2 m - 71.8 m based on slope differences of the west, south, and east side transects.

From 1995–2025 (Figure 4 & 5), the park has lost 18 m² of beach area, averaging 0.6 m²/yr despite renourishment efforts. The CVI was calculated at 20.4, and tidal range error (Figure 6) at 21.2-71.8 m. Frequent hurricanes in recent years have accelerated erosion, moving sediment around the southern tip and into Boca Grande Pass.

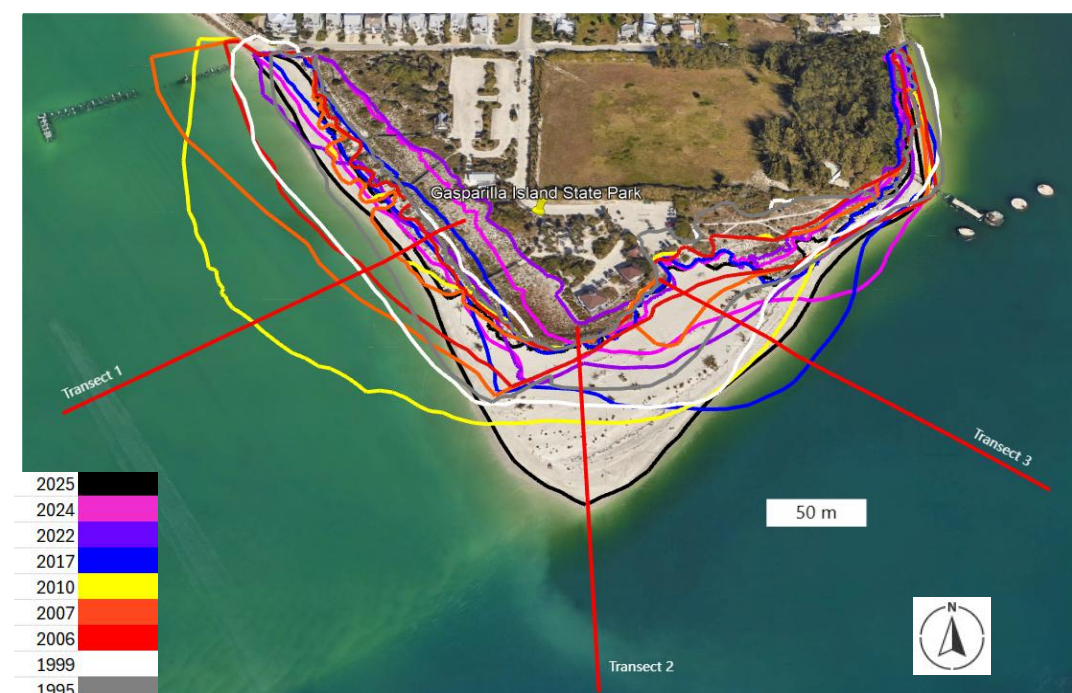
Figure 4. Mapped beach area changes for 1995-2025 with west, south, and east transects. 18 m² total area loss with avg. of 0.6 m² per year.

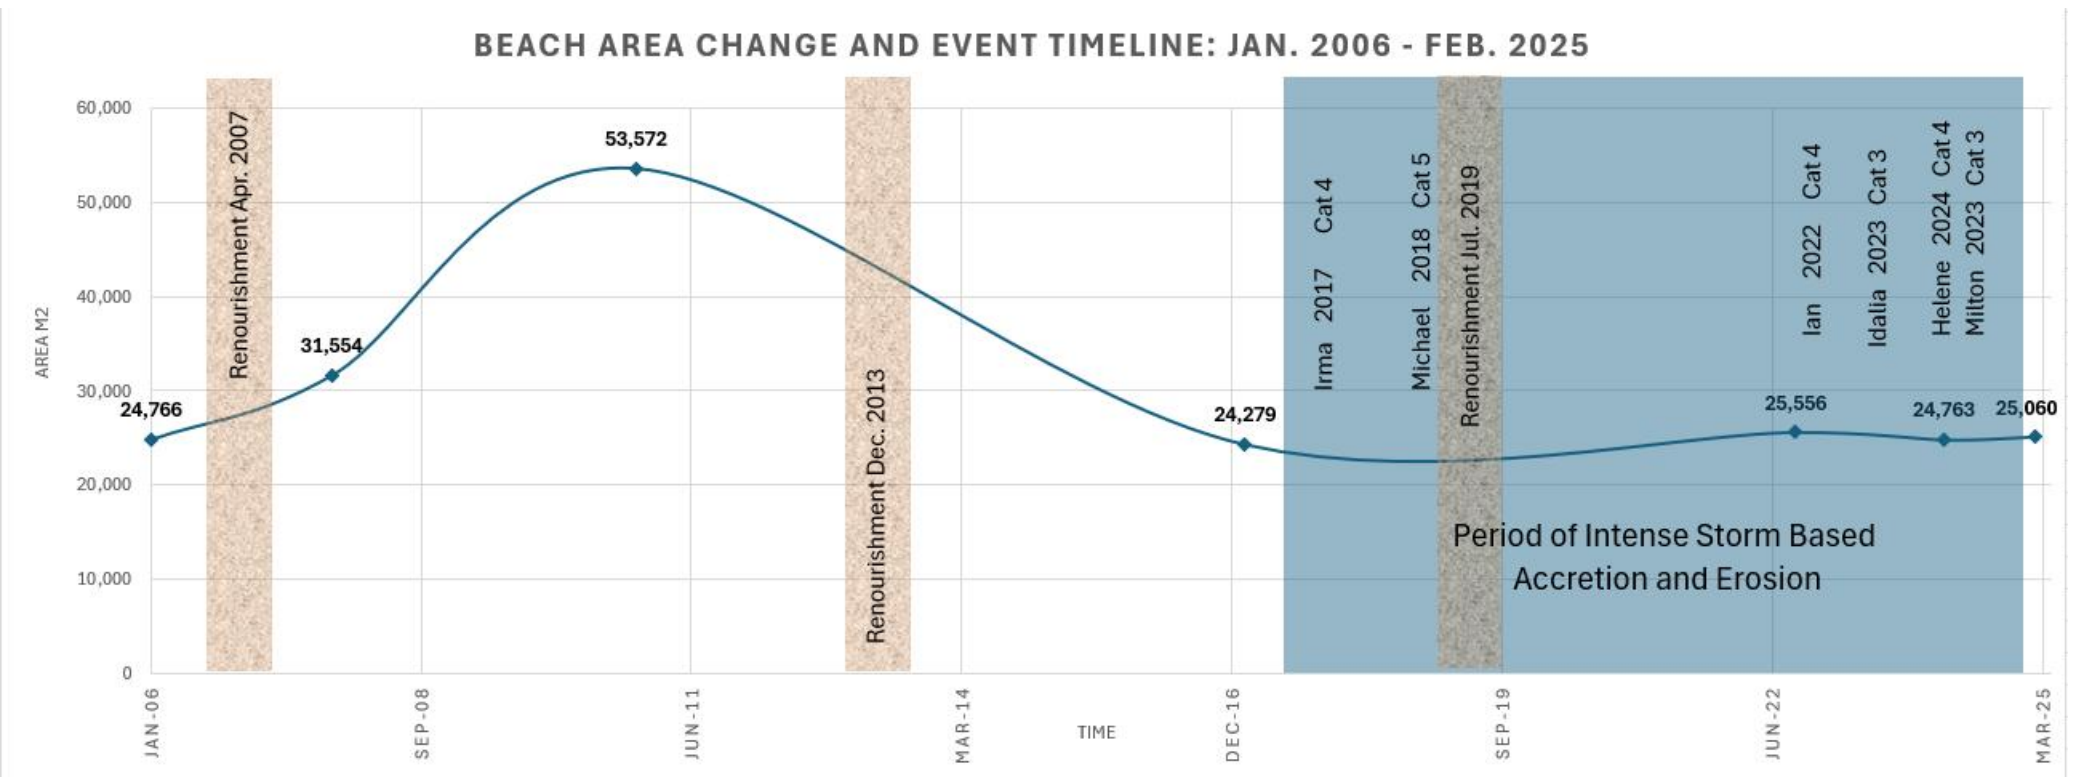
Figure 5. Beach area change over years 2006-2025 showing renourishments from years 2007, 2013, and 2019. More frequent storms at greater intensity have impacted sediment erosion and accretion rates along the southern tip of the park.

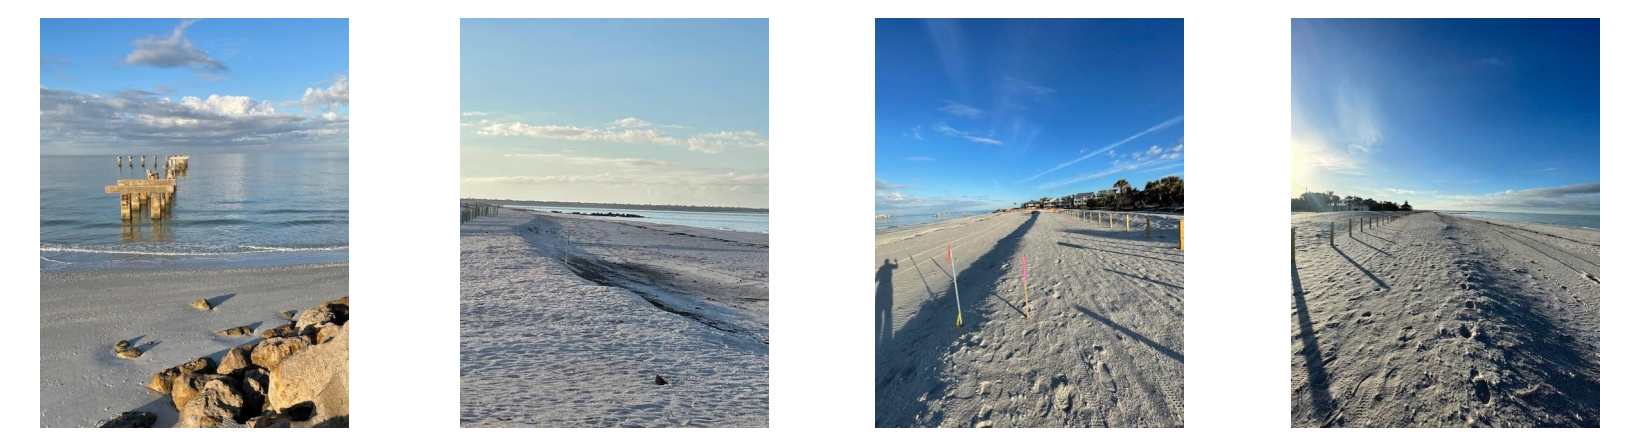
Figure 7. Field work picture collage of the beach before upcoming 2025 renourishment.
